The TGIF CHRONICLES

Week Ending Friday, October 29, 2004

Volume 2 – Issue 35

1. WHEN THE INSURED CRIES OUT FOR HELP – Ron Wilkes - Editor

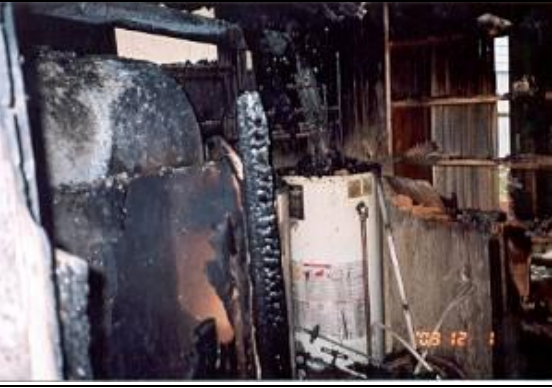
On Saturday, November 22, 2003, the insured left home that morning to run errands, and returned that afternoon to find the fire department on site. The residence had been gutted by fire which started with a short in the wiring in the crawl space.

attended the site as to the extent of damage and restoration required to the structure. Our position has been that the roof is removed completely; the interior should be stripped out to expose the framing; and the exterior wall cover should be removed completely back to the exterior wall sheathing, as a minimum requirement.

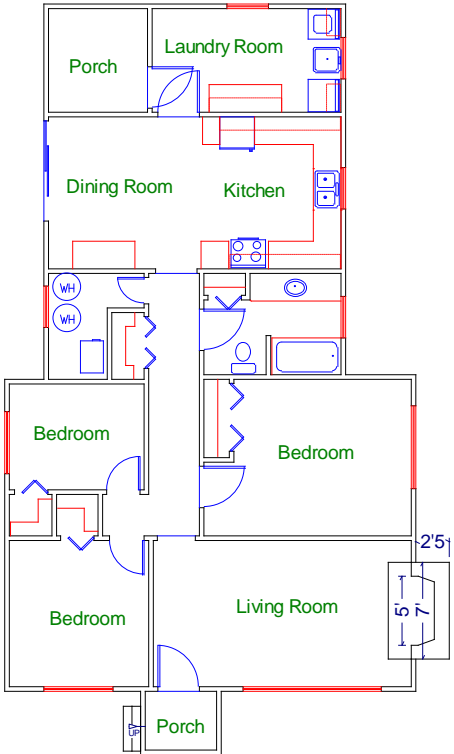
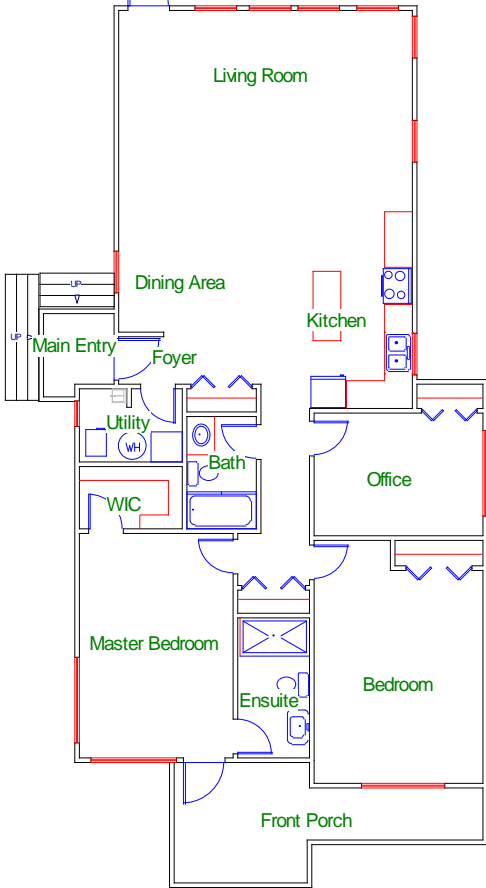
- The floor was constructed in three separate sections at different heights.
- The three separate heights were leveled off using additional sub flooring.
- The original thought was that there were 4 support posts; however there are 6 support posts not located where they were originally thought to be.
- There are 3 separate beams running from front to rear of the floor and not one as originally thought to be.

- The floor joists are on 12 inch centers and not 24 inch centers as originally thought to be.
- The reduced size of centers will increase the bridging sets required.
- There is a wood sill around the perimeter of the foundation, which was not thought to be there originally.

- Relocate the front and rear porches to accommodate changes
- Increase the square footage to accommodate changes
- Increase the ceiling height to 9 feet to accommodate changes
- Eliminate the crawl space
- Elevate the floor by 18 inches
- Change the wood floor to slab on grade with drain rock underneath
- Change to forced air heating to radiant hot water in slab
- Move all electrical boxes to utilities room
- Re connect water and sewer lines to road
- Resurvey the property
