The CHRONICLES Newsletter

Volume 3 – Issue 19

October 15, 2005

THINGS ARE NOT ALWAYS WHAT THEY SEEM TO BE –

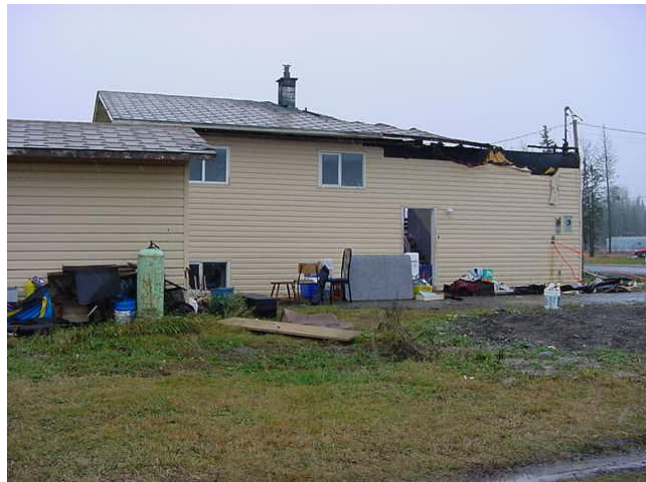
A view of the “half gone” roof.
The south half of the roof had
burned away during this fire.

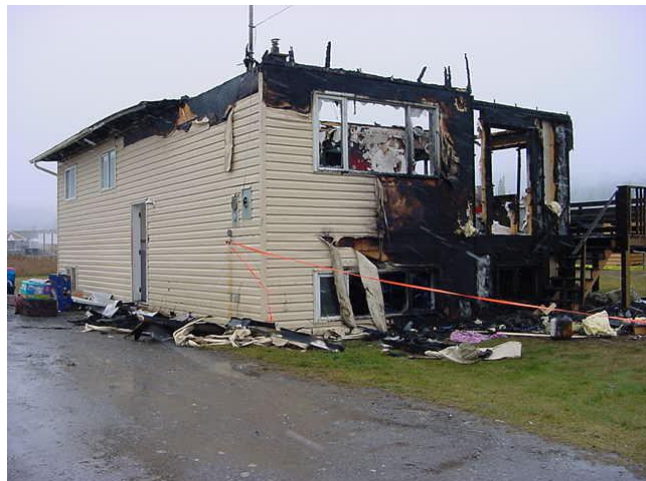
The house from a different angle.
This photo doesn't clearly show it
but red arrow indicates an area
from the ground to the eaves
where there was heavy charring.
There was no apparent reason
for this burn pattern and initially
it looked like a separate set with
a flammable liquid. Under the deck
on the right side of the photo
there was also heavy burning,
again with no apparent reason
and this also appeared to be a
separate set.

The heavy charring in a separate location depicted by the arrow in photo 2 was from a 25 lb propane tank that the first witness at the scene had tossed down the stairs. It ended up against the building and when the valve released after it was exposed to the fire, propane flared up the side of the building, causing the heavy charring in that location. The Fire Dept. had removed the tank prior to our attendance.

The heavy charring under the deck and along the side of the building under the deck occurred later in the fire when the natural gas meter partially melted, allowing gas to flare under the deck and along the outer wall. The meter had also been removed prior to our attendance.

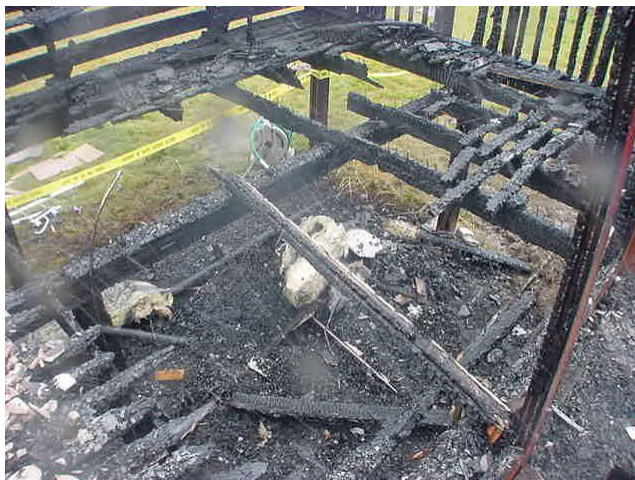
A closer examination of the deck revealed a large hole in the deck flooring. Did the fire start on top of the deck or below where we also found heavy charring?

The hole in the deck occurred early in the course of the fire, which was when the several joists near the hole in the deck were burned through from above. The Insured had living room furniture stored on the deck and covered with a plastic tarp. However, there was no apparent ignition source in the furniture on the deck. Further inquiry revealed that several children had been seen running from the deck prior to the fire. It is suspected they were having a small party under the tarp and probably smoking. The house was temporarily vacant during renovations.

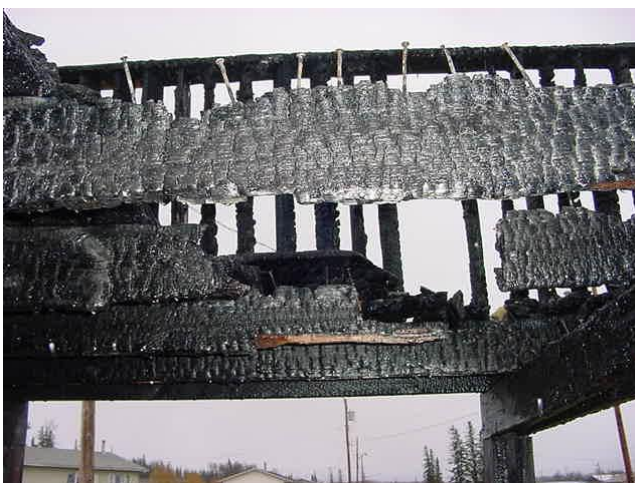
Examination of the joists in the deck revealed that although some had been heavily charred from below, there were several, in the vicinity of the hole in the deck, that were obviously burned through from above (see red arrows). Note the tapering burn. Also note the highest joist in the photo and that it is more burned away on the top than on the bottom. Furniture springs were found on the ground below.
