INTEGRAL CONSULTANTS

NEWSLETTER

DECEMBER, 2008

IT' RAININ' IN HERE HOSS!

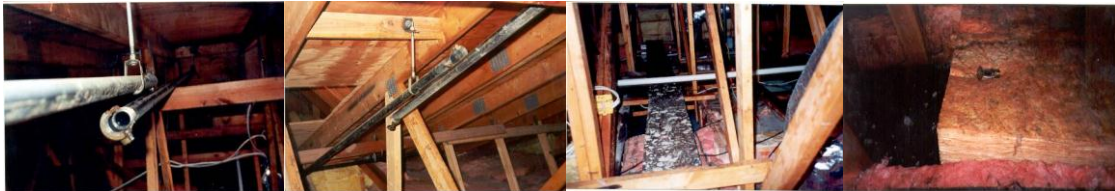
The dry pipe for the sprinkler system ruptured from freezing causing the air in the pipe to escape, which in turn triggered the main control valve to release water into the system. This in turn resulted in water under pressure escaping through the sprinkler system into the attic at 60 pounds per minute. With the pressure of the water it split the fitting, and dispersed water into the attic for a few hours before it was discovered, by triggering the alarm system.

The pressure of the water would spray onto the roof deck and truss system ascending down onto the insulation in the attic. With the amount of water coming from the pipe it would soon saturate the insulation, and fill up the ceiling joist portions of the trusses. The water would also seek the path of least resistance and run through the ventilation system, the holes drilled to feed wiring, and down the inside of exterior walls, and partitions, which it did.

The pipe that ruptured was almost directly above the bar in the banquet room, and stains from the discharge can be seen on the underside of the roof deck today. The accumulation of water in the attic spared the residence area, and ran towards the left elevation of the building. The weight of the water on the drywall ceiling soon would bring the drywall crashing into the banquet room.

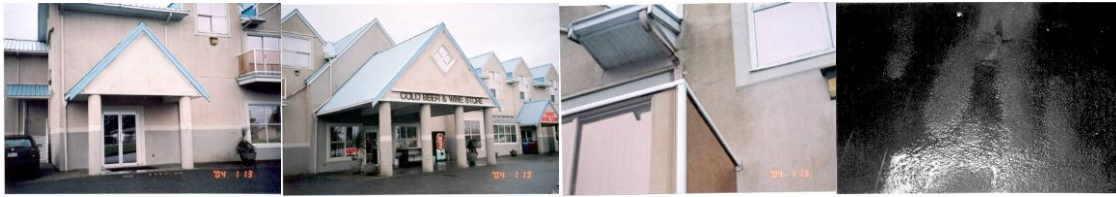
Although the building envelope would not show signs of being breached due to this loss, it would do so in the future which it has. Any damage to the building envelope would show as bubbles or blisters to the exterior stucco. Since stucco is not a moisture barrier, it was

This hidden damage would be to the left front, left, and left rear elevations as shown below.

necessary to remove the stucco, replace the building envelope cover, and re stucco all elevations where there is stucco applied.

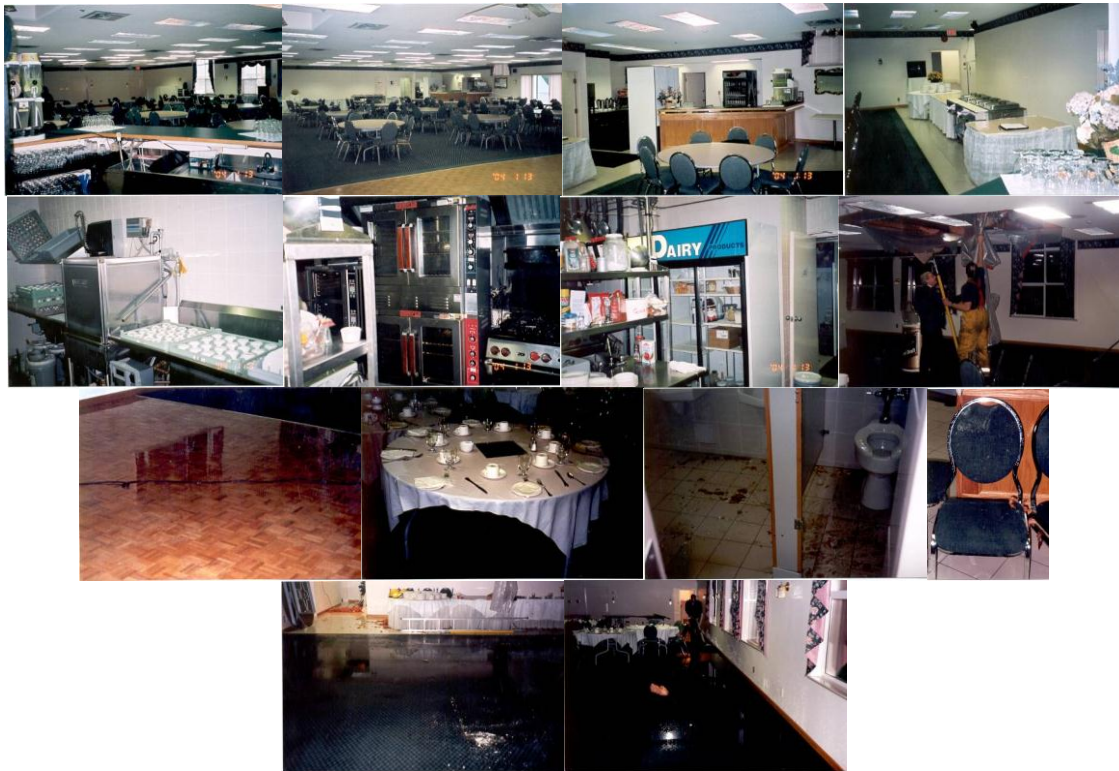
The water ran through the taped joints of the drywall, the light fixtures, the ventilation ducts, and diffusers in the ceiling of the Banquet Room. The room had just been set up for a banquet in the next few days. The weight of the water and the wet insulation brought part of the ceiling down onto the tables, chairs, and floor in the banquet room, and the washrooms. It saturated the partition walls to the washrooms, kitchen, and halls. As the water accumulated on the quarry tile, carpet, and hardwood dance floor it spilled out onto the balcony and over onto the ground below, as well as entering the main, side, and rear exits, down the staircases and out the doors. It was a couple of inches deep in areas on the second floor. It did not penetrate the walls into the residence but did flow into the storage over the entrance canopy to the beer and wine store.

In general, on the upper floor the banquet room sustained the brute force of the water damaging ceiling, walls, floors, built-ins, doors, and occupancy design fixtures with some of the same damage occurring in the washrooms. It spilled onto the kitchen, halls, rear staircase, side staircase, and front staircase. There is plywood to create a fireguard, and seismic reinforcing behind the drywall to the walls, which would expand and dry out

jeopardizing the integrity of the building envelope. The amount of water and weight of the water would have breached the integrity of the vapour barrier as well.

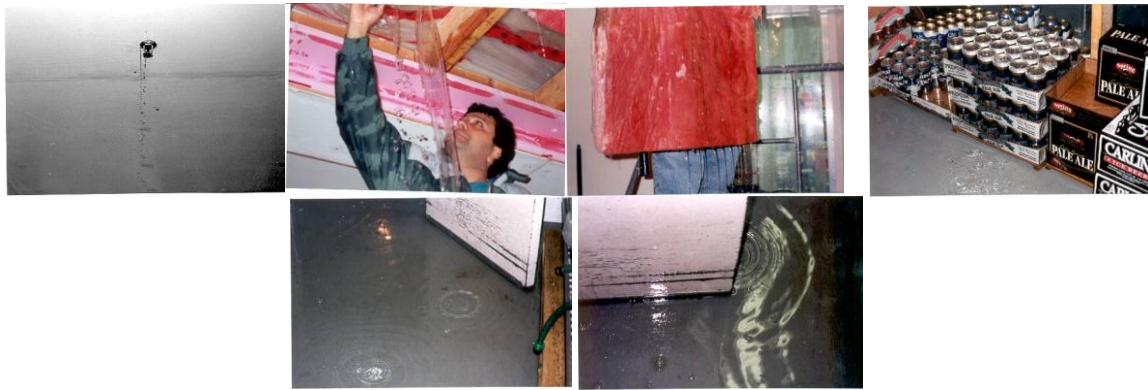
The bar is directly above the interior entry of the beer and wine store which would place the majority of the water that ran down from the second floor into the beer & wine store, the cooler, and the maintenance and storage areas. Once the water began to puddle in these areas it ran through into the reception, office, lobby and meeting room areas. It also entered from the cooler into the furnace room down the hall corridor spilling into the office, laundry and sewing, electrical room, and storage areas. It stopped at the entry to the kitchen to the pub because that floor is higher than the floor it landed on. Some ceiling damage did occur to the office, reception and hall areas.

The ceiling has two layer of drywall above the t bar ceiling system. The first layer is fastened to the floor joists, and then a track is fastened to it which has drywall fastened to it to create a sound barrier. There would be insulation in the ceiling / floor joists to dull the sound as well. Again, there is plywood to create a fireguard, and seismic reinforcing behind the drywall to the walls, which would expand and dry out jeopardizing the integrity of the building envelope.

In summary, on the main floor the Cooler, and Beer & Wine Store suffered the major water damage with some additional damage to the Reception, Lobby, Halls, Office, Laundry, Maintenance and Storage areas. The floor in all areas except the Pub suffered water damage.
