**INTEGRAL CONSULTANTS**

# NEWSLETTER

**NOVEMBER, 2008**

# GUSTNADOES

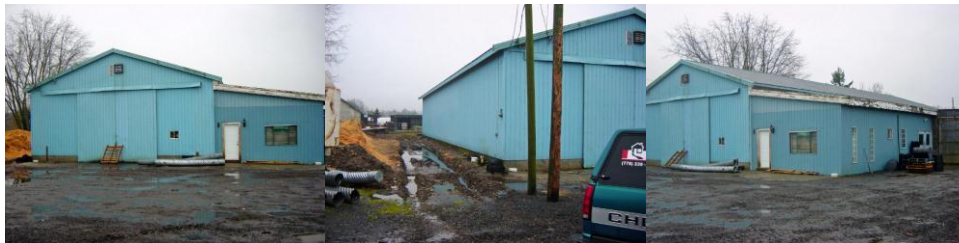
It appears that gust of wind sometimes referred to as *Gustnadoes* which are common in the Lower Mainland of British Columbia is what caused the damage. They can be mistaken for a Dust Devil because they appear as one. The main difference is that *Gustnadoes* are accompanied by high winds and rain where as a Dust Devil does not have the rain accompanying them. *Gustnadoes* can pack a hard punch like a Tornado and that is where they stop - at one punch. If you have ever driven down the road and saw a healthy single tree snapped at the base of its trunk and no other surrounding trees had damage it is more than likely it resulted from a *Gustnadoes*.

*Gustnadoes* will seek out the path of least resistance, such as an open door, or a piece of loose siding or roofing panel. In this particular case, the site caretaker stated that the building was shut up at the time of impact; therefore the wind found that loose piece of siding and entered the building. Once it gets in the building at high speeds it looks for a way out, so it places pressure on the ceiling, roof, and other walls. In the particular case it

appears that it left the same way it came in. This only takes a few seconds for the damage to occur.

Most steel roofing and siding manufacturers of this nature place only a 25 year warranty on their product due to the suns rays deteriorating the neoprene washers and they lose their integrity and fail. In this particular case the wind has escalated the complete failure of these neoprene washers to this building.

The steel panels may have a few more years in them, depending on how they have been maintained over the years, but in order to determine if these existing panels do, they need to be tested by an engineering firm in order to measure the actual years left in them. The cost of having the test completed would have to be weighted against the actual cost of replace the panels.

The cost to repair this building due to leaks in the roof, and siding was \$ 30,000 whereas if it had been maintained regularly the cost of repairs would have probably been in the neighbourhood of \$ 7,500 by replacing washers and screws where the Gustnado tried to escape.
