INTEGRAL CONSULTANTS

NEWSLETTER

JANUARY, 2009

I'LL HUFF & PUFF 'TIL I BLOW YOUR HOUSE DOWN!

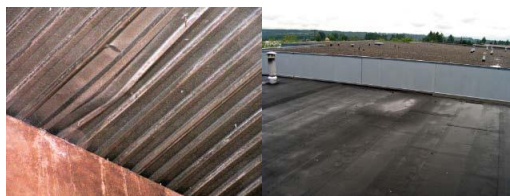
No damage was mentioned to the structural component, however our observation shows that the metal deck has been buckled in one spot about one quarter of the way along the left (east) wall from the south east corner of the roof (see photos below).

This damage to the structure could be old damage or it could have been caused by an object striking the roof during the wind storm after the roof cover and insulation had lifted. There is no way to indicate which it was and it should have been addressed before the new roof cover was installed by roofing contractor for the restoration team. It could develop leaks in years to follow.

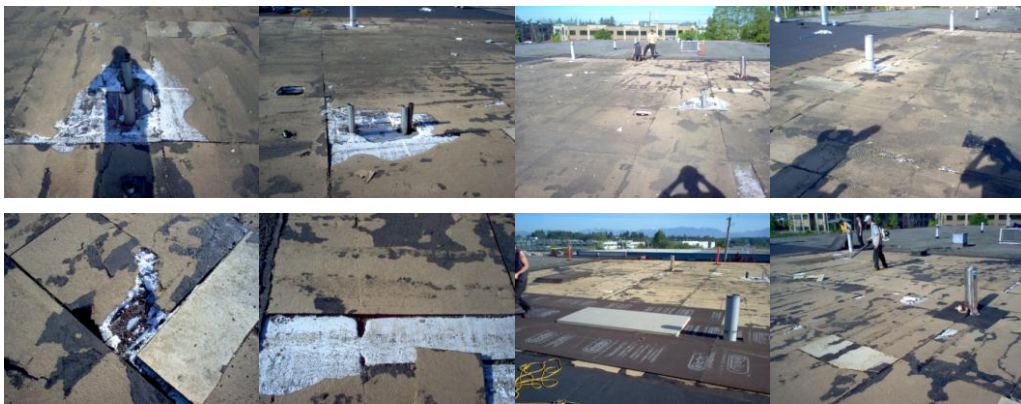
The remedial work commenced on May 23rd. Hidden damage was discovered on May 23rd and May 24th (see the following photos).

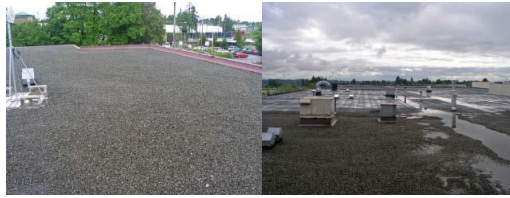
The surplus gravel from the debris field (see photos above) was recycled by placing it on the old section of roof in order to help hold it down (see photos below), however this section of roof should be replaced by the insured because it poses a liability hazard as it is incorrectly fastened (see engineers report).

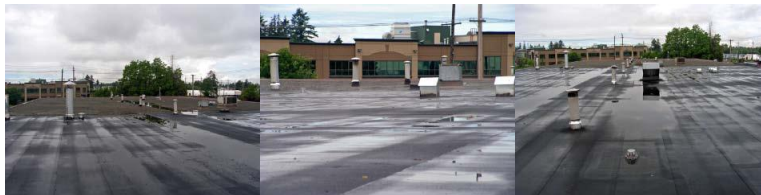
The new hot mopped roof area has had new vents added by our roofer to the section of roof that they have replaced (see photos below).

The center section of the east section of roof replacement was repaired by our roofer for better drainage (see photo above right).

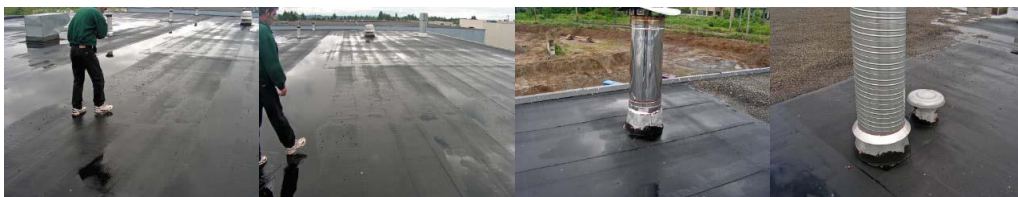
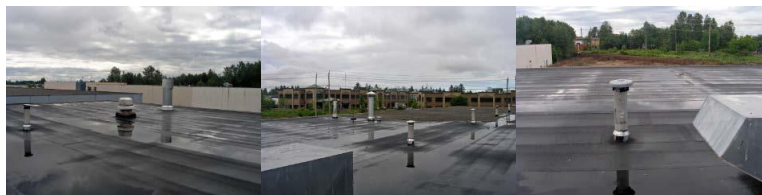
Bubbles have appeared in areas of the restoration company's roofer's application (see below). They should be left until hot weather to see if they subside. Our roofer will inspect them in the fall at which time a decision can be made whether to acknowledge them or open the area up and repair.

The old damaged vents were reinstalled by the restoration company's roofer which should have been replaced (see below).

One of the vents has a collar missing on the restoration company's roofer's side (see below). Our roofer is correcting this vent.

In summary, we should address the bubbles this fall if necessary, and accept that this remedial work is complete.
