INTEGRAL CONSULTANTS

NEWSLETTER

MID MARCH, 2009

WHAT THE SUN CAN DO!

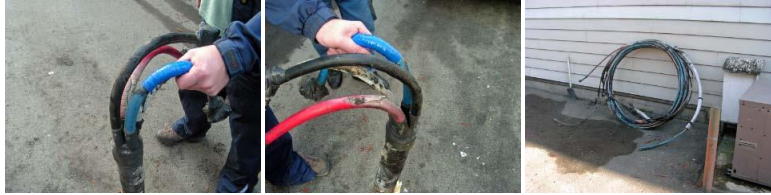
The power lines supplying power to the complex caught fire the evening of November 8th, 2006, at the junction where the supply lines from the pole are attached to the lines to feed the building. The lines from the pole to the building were changed by BC Hydro in the early hours of the morning of November the 9th.

Once the damaged lines were removed, the condition of those lines showed ultra violet rays from the sun had deteriorated the protective casing exposing the wire itself (see photos below). This could cause two of the hot lines to touch each other causing the fire.

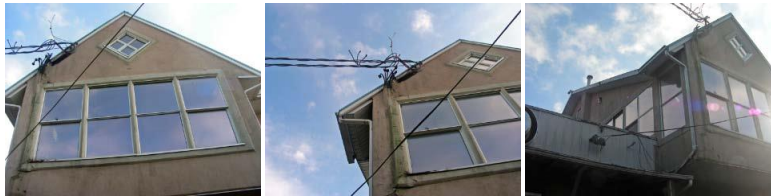
The fire damage to the structure was confined to the immediate area of entry point of the electrical service and to the exterior of the building. It is the gable section at the rear of the building (see photos below).

Aside from damage caused by melting plastic, flames, and heat, there is some damage caused from extinguishing the fire with water from the fire hose, powder from the suppressant used for the electrical portion of the fire, and fire personnel entering and existing the building with equipment.

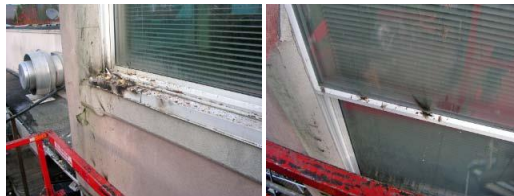
The end windows on each corner of the gable suffered damage to their frames and glazing (see the following photos). The other window units had their thermo glazing checked to ensure their seal is still intact.

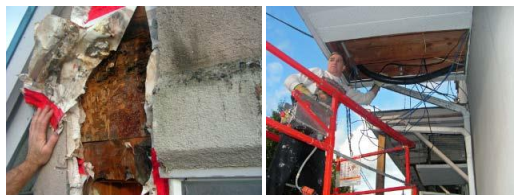
The building envelope and the EIFS finish have been compromised to the gable end and possibly around the corner to the corner where the original structure joins this new addition. The exact extent of the damage was determined once the trade removed the damaged section immediately behind the power cables and followed it to each side of the cables. It visually appeared to be just to the right of the centre of the end window unit facing the alley. The cause of the damage was the angle and pressure of the water of the fire hoses. They also damaged some fascias and the immediate gutter. The following photo shows both heat melting the Styrofoam and water damage. Water poured out of the tech cables when they were being removed.

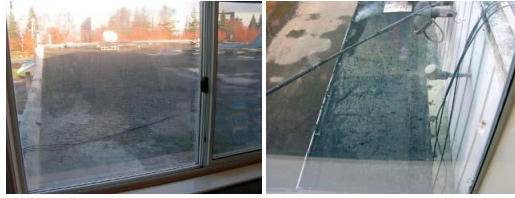
The powder (green in colour) residue from means to extinguish an electrical fire is directly below the area on the flat tar and gravel of the pub roof and the roll roof of the loading dock (see photos below).
