INTEGRAL CONSULTANTS

NEWSLETTER

JUNE, 2009

TOO MUCH WATER TOO SOON

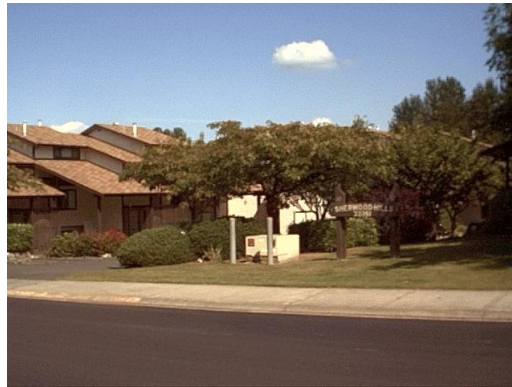
The complex was approximately 16 - 18 years old at the time of our inspection and the perimeter drainage system is Big O pipes. Big O piping is a flexible 6 inch pipe that can collapse with pressure from land movement or roots over the years.

Ground water enters the residence behind the furnace on the front foundation wall. Over the years there have been several attempts to rectify the problem with no success. Repairing perimeter drainage to the front of this residence could become an expensive proposition as they have had cameras inserted in the drains in the past and blockage had been blasted by water pressure to remove it. The water still pools in front of the entry screening and the drains cannot handle the volume. The most economical solution is to divert the water out to the main road where a catch basin and the main drain are a short distance away.

The driveways slope towards the residences and there is a gravel catch basin located at the bottom in the center of the driveway. Gutters and down spouts are also drained into these catch basins. During heavy rain storms these basins may not be able to handle the volume of water and consequently the water can run under the garage door into the garage and on into the basement through the garage entry door. Upon inspection of these catch basins it was observed that they are full of silt. Since these types of catch basins

are not connected to the drainage system but drain directly into a gravel pit in the ground, they should be cleaned out at least once a year.

When we inspected the roof cover, gutter system, drainage systems, and catch basin in this complex, we found that the roof cover is an interlocking shingle roof that has been installed over a pre existing strip shingle and the replacement shingles overlap about half way into the gutters which is a correct application. However the upper roofs drain onto the lower roofs without any control which will shorten the life expectancy of the roof cover as well as cause a breach of the building envelope.

Although constructed to building code at the time of construction, the lower gutters are too small to cope with the volume of water and they are too small for an overlap of an interlocking shingle and therefore should be replaced with a larger size.

The solution to this one was simple. Although ideally it would be better to have these catch basins connected to the main road drains, they should be cleaned and the crushed gravel renewed annually. After each maintenance session has been done, a member of the strata council should keep a watch on them for performance after heavy rain storms and if the solution is not working, then the next step would be to connect them to the storm drains that run throughout the complex's road systems.

The complex has 48 units with damage in each unit although at different stages. The perimeter drainage can be corrected by replacing the Big O drain tile with perforated PCV pipe and connecting it to the main storm sewer, changing the lower gutters, adding extensions to the downspouts from the upper story, and changing the catch basins with a strip basin across the front of the garage door and connecting them to the storm drains for all units. A special assessment was collected for the sum of \$ 480,000 to correct the construction deficiencies and upgrade the building code requirements from the time of original construction.
