INTEGRAL CONSULTANTS

NEWSLETTER

AUGUST, 2009

TIMBER!

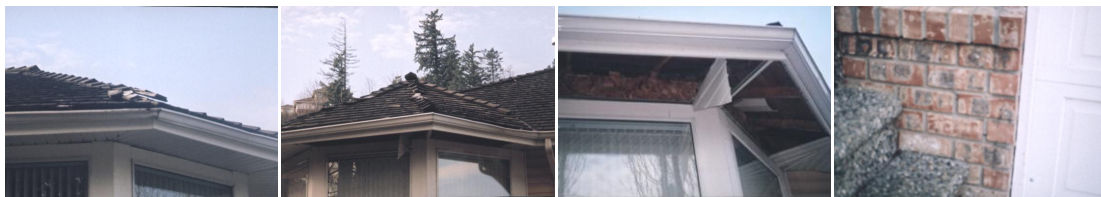
A tree being topped by the neighbour to the south fell onto the Insured's roof, striking the roof over the dining room and damaging the wood shakes, trusses, fascia, soffits and gutters. The shock of the impact was felt throughout the residence. An inspection and observations of the attic made by an independent third party attest to the assumed damage in the attic. The tree then bounced, striking the roof over the living room area and landing on the east fence. The lower portion of the trunk damaged the southern fence line as the tree fell.

It is visually obvious that the shock of impact was felt throughout the residence. The following observations have been made:
