INTEGRAL CONSULTANTS

NEWSLETTER

SEPTEMBER, 2009

WHAT THE SUN CAN DO!

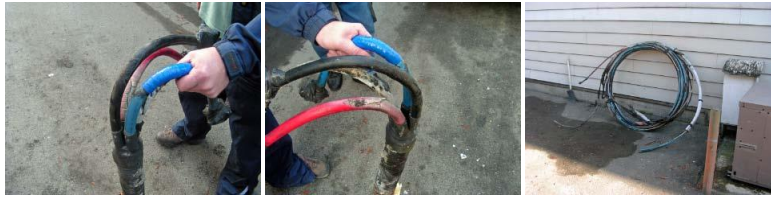
The power lines supplying power to the complex caught fire the evening of November 8th, 2006, at the junction where the supply lines from the pole are attached to the lines to feed the building. The lines from the pole to the building were changed by BC Hydro in the early hours of the morning of November the 9th.

Once the damaged lines were removed, the condition of those lines showed ultra violet rays from the sun had deteriorated the protective casing exposing the wire itself (see photos below). This could cause two of the hot lines to touch each other causing the fire.

The role of wire (photo above) and the sun damaged tail pieces was saved, and stored in a secure area on site.

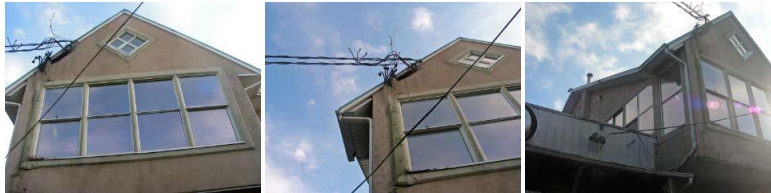
The fire damage to the structure was confined to the immediate area of entry point of the electrical service and to the exterior of the building. It is the gable section at the rear of the building (see photos below).

Aside from damage caused by melting plastic, flames, and heat, there is some damage caused from extinguishing the fire with water from the fire hose, powder from the suppressant used for the electrical portion of the fire, and fire personnel entering and existing the building with equipment.

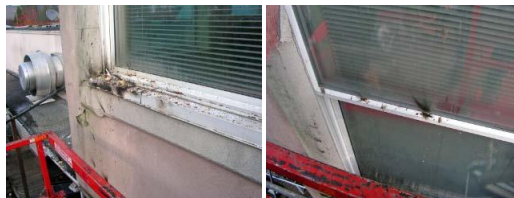
The end windows on each corner of the gable suffered damage to their frames and glazing (see the following photos). The other window units had their thermo glazing checked to ensure their seal is still intact.

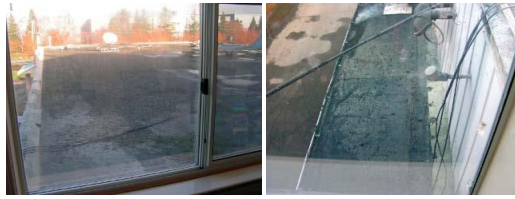
The powder (green in colour) residue from means to extinguish an electrical fire is directly below the area on the flat tar and gravel of the pub roof and the roll roof of the loading dock (see photos below).

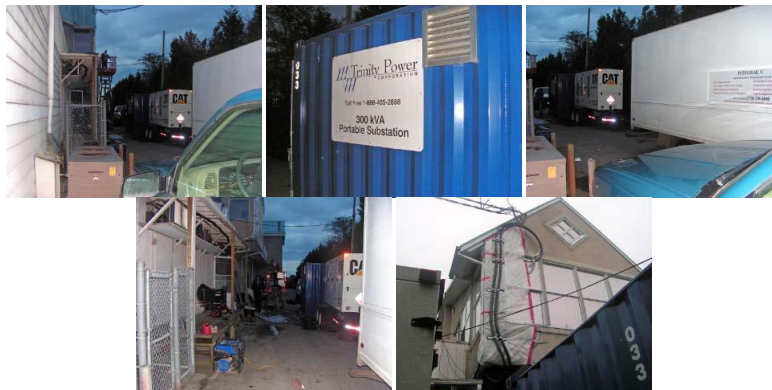
A portable sub station was brought in immediately which was large enough to service the entire complex and temporary service was up and running by 5:00 pm the next day. In the meantime, an electrical engineering report was conducted, and an effective method to commence restoration was explored.

Within a week, permanent service was installed, and within 30 days after that repairs were completed. The total cost of loss was confined to in excess of \$ 100,000 including business interruption and consequential damage from loss of stock and product.
