NEWSLETTER

JANUARY, 2010

CS06.01.04 – A SALMON RUNS THROUGH IT

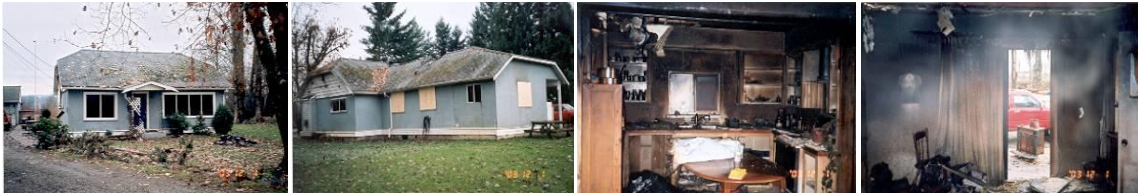
This residence, which had suffered a fire loss that severely damaged the roof and gutted the interior, was infringing on the Department of Fisheries set back for a salmon stream that ran through the property. Fifty percent of the home was constructed on this set back. The construction also bordered the street right of way setback for the municipality it was constructed in.

Add to the two problems above, it had a dirt crawl space which seasonally flooded with the stream overflowing its banks several times a year. That was a health concern for the regional health authorities, and the crawl space was so restricted that it qualified as a confined space which brought the WCB Safety Branch into play.

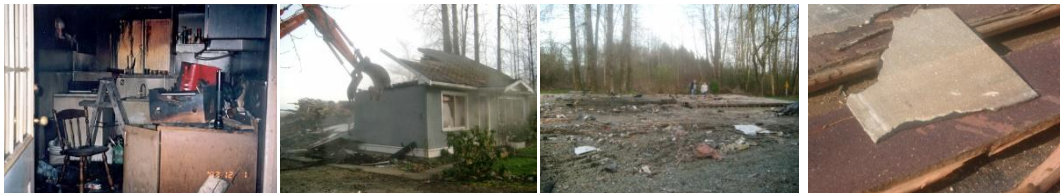
The first step was to get the building torn down in order to inspect the floor, the foundations, and the footings as the fire started in the crawl space due to electrical arching.

The demolition permit resulted in an extra \$1,000 cost because of the closeness of the salmon stream. Once this was accomplished, a full inspection of the floor by the adjuster and us determined that the floor had to go and could not be repaired because it had been constructed in three separate stages, on three different levels, with several sub floors being added to bring it all up to one level. Asbestos was found in the tiled flooring and the fire had eaten through it in too many places along with it sitting exposed to the elements for months while the demolition permit was negotiated and obtained.

Once the floor had been removed, it exposed more problems. The foundation and footings had been constructed on top soil from the stream bed, and did not fit under the residence correctly; therefore the walls had buckled inward in places. The residence had been moved to its existing location in 1961 on a foundation that had been poured in place before it arrived.

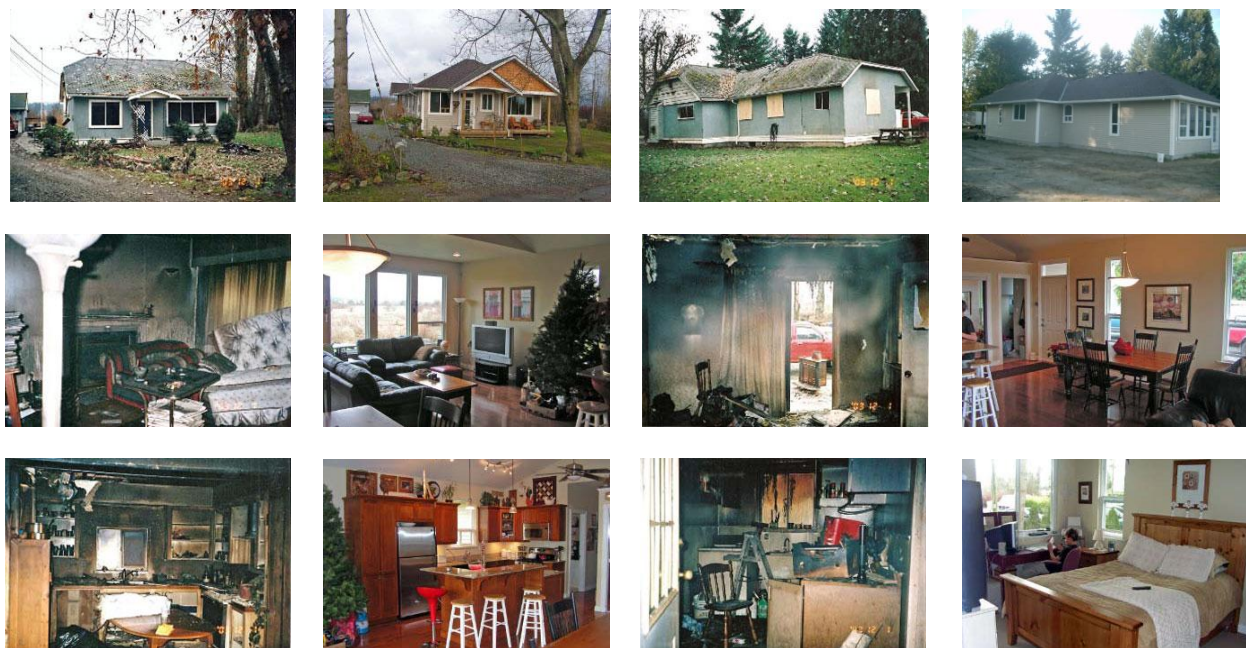
The insured's share of the improvements and betterments was \$22,000.00. The total loss was \$185,000 including the insured's portion. The following are some before (left photo) and after (right photo).
