# NEWSLETTER

APRIL, 2010

## CS06.11.11 – WHAT THE SUN CAN DO!

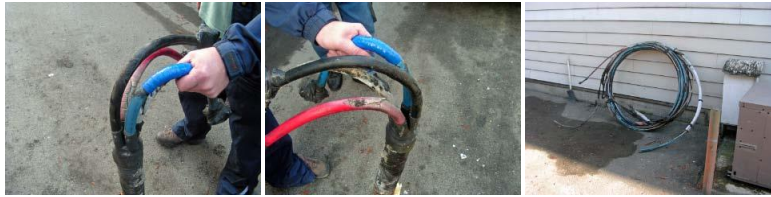
Once the damaged lines were removed, the condition of those lines showed ultra violet rays from the sun had deteriorated the protective casing exposing the wire itself (see photos below). This could cause two of the hot lines to touch each other causing the fire.

The role of wire (photo above) and the sun damaged tail pieces was saved, and stored in a secure area on site.

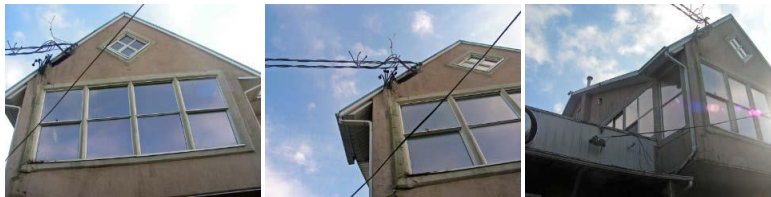
The fire damage to the structure was confined to the immediate area of entry point of the electrical service and to the exterior of the building. It is the gable section at the rear of the building (see photos below).

Aside from damage caused by melting plastic, flames, and heat, there is some damage caused from extinguishing the fire with water from the fire hose, powder from the suppressant used for the electrical portion of the fire, and fire personnel entering and existing the building with equipment.

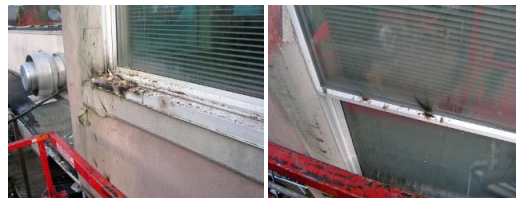
The end windows on each corner of the gable suffered damage to their frames and glazing (see the following photos). The other window units had their thermo glazing checked to ensure their seal is still intact.

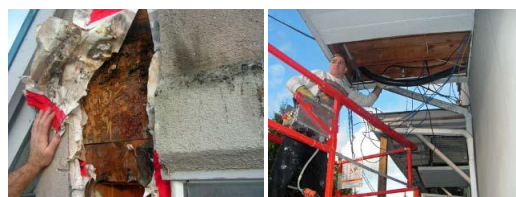
The building envelope and the EIFS finish have been compromised to the gable end and possibly around the corner to the corner where the original structure joins this new addition. The exact extent of the damage was determined once the trade removed the damaged section immediately behind the power cables and followed it to each side of the cables. It visually appeared to be just to the right of the centre of the end window unit facing the alley. The cause of the damage was the angle and pressure of the water of the fire hoses. They also damaged some fascias and the immediate gutter. The following photo shows both heat melting the Styrofoam and water damage. Water poured out of the tech cables when they were being removed.

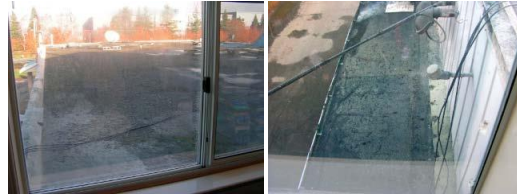
The powder (green in colour) residue from means to extinguish an electrical fire is directly below the area on the flat tar and gravel of the pub roof and the roll roof of the loading dock (see photos below).
