NEWSLETTER

JUNE, 2010

THINGS AREN'T ALWAYS WHAT THEY SEEM

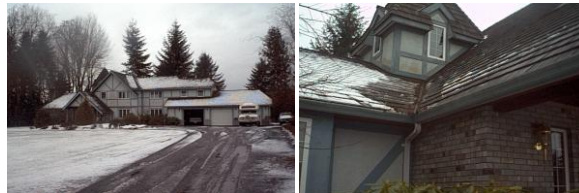
When we arrived on site, we found water running out of the light fixture in the Family Room in the Basement into a pail that the insured had put in place. The textured ceiling had wet spots showing through and the seams opening up. The carpet was wet and the globe of the light fixture lay in pieces. There was a heavy moisture reading to the center beam dividing the Family Room and the Billiard Room. The drywall on the beam was starting to buckle from the water.

We went upstairs to the Main Floor to locate the area on this wall which is directly above the water damage below. These rooms have vaulted ceilings. We checked the interior partition wall between the Living Room and the Sun Room for moisture content. All readings were normal.

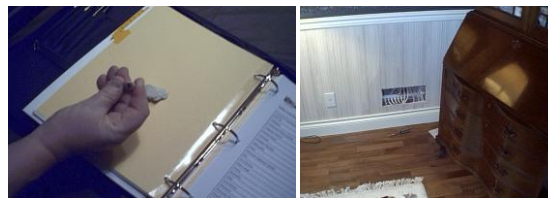
The insured left around noon and returned around 8 that evening. When they went down stairs to see how the room was drying out, they found water pouring through the ceiling fixture again. We responded to their call and decided to cut a hole in the ceiling at point of saturation to the drywall in the ceiling. We found a plumbing pipe and there is no plumbing to that section of the home. It could only be part of the radiant heating system. That morning, we had the boiler checked to see if the pressure was down. The pressure was normal at that time.

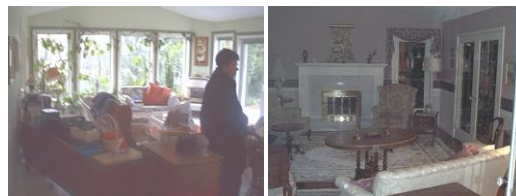
We went upstairs directly above the pipe and found an access panel in the wall behind the china cabinet. Upon opening the access panel, we found the distribution branch for the radiant heat in that part of the residence. One of the rubber hose piping (rubber is used because it is flexible enough to join the line in the floor with the connector to the branch line) had ruptured and was leaking. It had been installed in a standard partition wall rather than a mechanical wall (normally plumbing, air conditioning, or heating lines run in a mechanical wall constructed of 2 x 6 rather than 2 x 4). When the drywaller installed the drywall to the Sun Room side it squeezed the hoses into the rest of the line. It put pressure on the line causing it to rupture. When we repaired the line that ruptured, we found that some of the other lines had also been ruptured by the disturbance. We repaired all lines to insure that another occurrence like this one does not happen again. It will be recommended that a register is installed on the Sun Room side to give the additional room that a normal mechanical wall would allow.

The wall on both sides of the partition wall is showing heavy moisture content. We will allow them to dry naturally without a fan and leave the furniture away from the wall until it is dry. There is wallpaper on the Living Room side and paint on the Sun Room side.

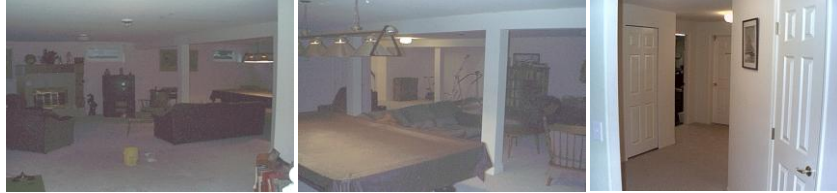
Since the heating system is zone controlled, heat is called for through individual thermostats in each zone. When a zone is closed and not calling for heat, there is no circulation of water in the lines. When we tested the water in the morning, the water was cold running out of the light fixture. When we tested the water that evening the water was luke warm indicating it is coming from the heating system.

We believe that the zone that ruptured called for heat in the early morning hours, ruptured and started to leak into the basement ceiling in the Family Room. The insured found the damage when they went down to the basement and called us. The zone that caused the damage has a heavy traffic area for opening and closing of exterior doors, thus it called for heat constantly but was not delivering due to the rupture. Once we arrived on site, we started using the basement door for entry rather than the front door which allowed the zone's thermostat to stop calling for heat. It stopped calling for heat which means it closes the line at approximately the same time that we had cleared the debris from the roof valley and gutters. After the insured went out the thermostat called for heat again and the damage resumed.
