INTEGRAL CONSULTANTS

NEWSLETTER

OCTOBER, 2008

The STEEPLE

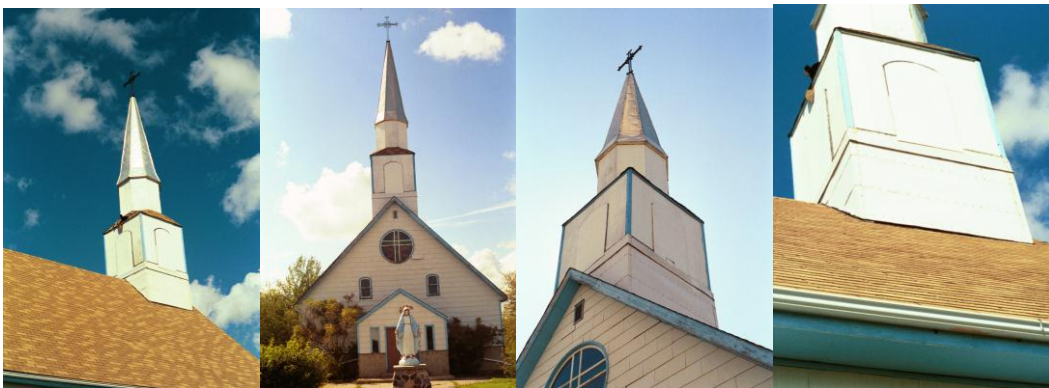
By four o'clock in the afternoon, it was a full fledged windstorm reeking havoc on this small community. When it passed it didn't get to hurricane force or produce funnel clouds that touched down, but it was severe enough to leave a path of destruction in its path. It included the small historic church on the main street, as it had forcibly pulled nails, screws, and bolts to reposition the steeple to be left leaning towards the direction the storm was traveling as it passed through.

A crane had to be brought in to lift the steeple and bell tower off the roof while the roof was repaired beneath it and then placed back down on the roof after having the base of the structure rebuilt. Although the shingles were not obsolete and had been replaced only a couple of years ago, it got a new roof cover as well because of damaged shingles caused by this windstorm.

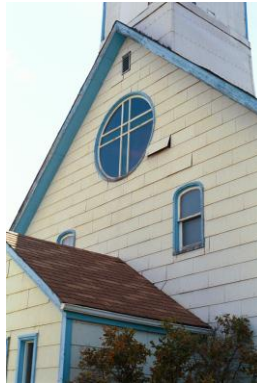
But the damage didn't stop there, the asbestos siding that was applied in the sixties, to renew the original siding, also suffered wind damage. Asbestos is very harmful to one's health and has to be handled by professionals who specialize in asbestos removal.

This specialized crew installed scaffolding to all elevations and the entry addition, then they enclosed this area with a sealed tent including all windows and doors to these elevations with plastic designed for this use. They proceeded to set up a decontamination tent at the entrance to these work areas. Once tent has been erected in place, no unauthorized personnel shall enter the work area, only the workers. All personnel who enter the work area shall be dressed appropriately. An air monitor was set up in the enclosure and air samples before, during, and after removal of asbestos siding was monitored.

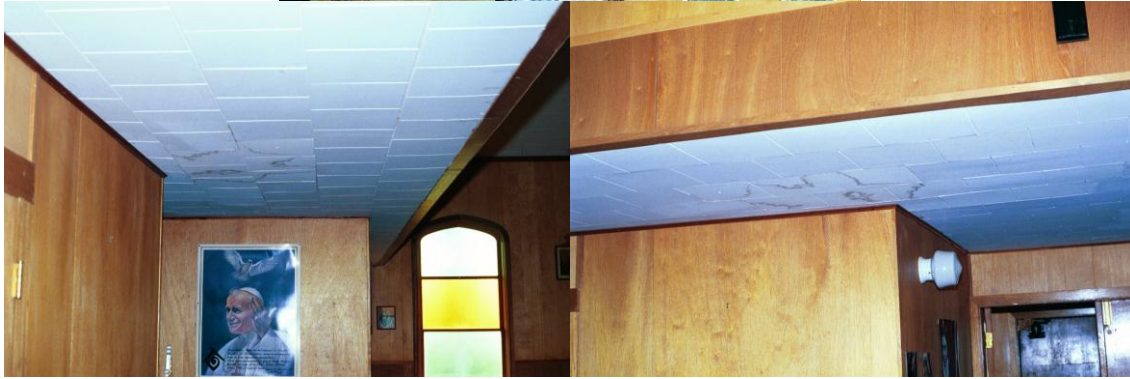
Before an asbestos removal job can commence, a licensed contractor is required by law to give a 10-day notification to the proper agencies to inform them that asbestos removal will be performed. The contractor must heppa vacuum all exterior wall surfaces, interior tent surfaces, scaffolding, and ground before removing tent, clean up all remaining debris from the ground and bag it, spray enclosed area with a fog spray mist to remove any residual fiber in the area and then remove the tent.

Although it had a 20 foot ceiling height in places, the church ceiling was the easy part of the restoration process. The existing ceiling tiles that were probably installed around the same time as the asbestos siding were also obsolete, so the entire ceilings in the church had to be replaced.

The cost to retrofit and repair this 2800 square foot church was \$ 150,000 for a new tiled ceiling, new composite roof shingles, and new exterior metal siding.
