INTEGRAL CONSULTANTS

NEWSLETTER

JULY, 2009

WHAT THEY CAN'T SEE WON'T HURT THEM!

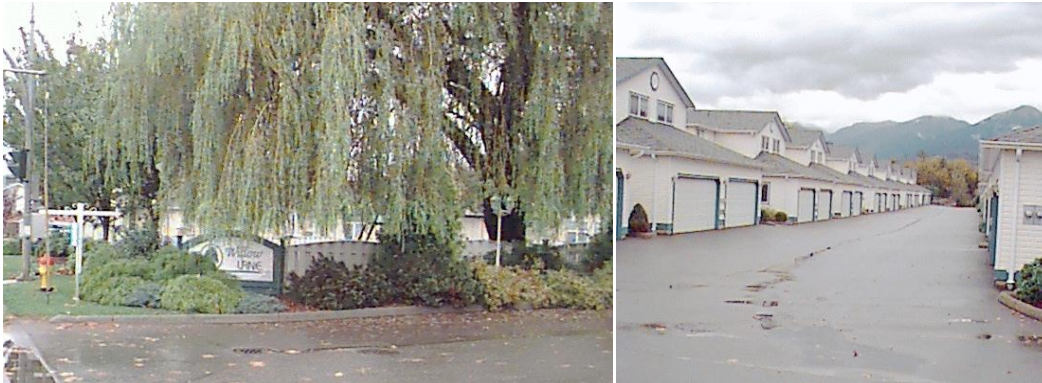
When we attended the site, the weather was overcast and raining adding to the heavy rain from the night before. The ground and lawn along the north fence line was saturated and wet with standing water. This condition can and has caused erosion, and can weaken the fence posts, etc. It was also observed that the neighboring property, was much lower and had constructed a retaining wall along the fence line on their property.

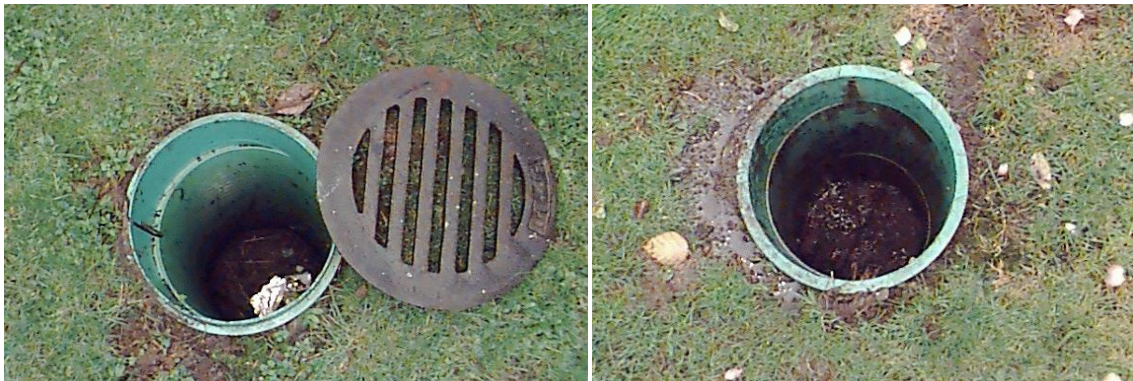
The natural run off of water is toward the north and east which would account for all the water on the north side of the property line. There have been some attempts at one time to deal with this water because there are catch basins along the property at different intervals.

They are ineffective because:

1. They are installed too high (above ground level).
2. They are not perforated to allow water to enter below the surface.
3. The lawn is not graded correctly for this type of drainage.

The solution would be to install a drainage system next to the fence on the subject property side along the perimeter to the rear fence line and then take it along the rear fence line to the storm drain at the end of the pavement in the parking area. In fact the parking area should have the drain moved to the center and the asphalt graded so that the area drains towards the catch basin. This would also resolve the problem in a previous report concerning a neighboring tree with roots extending into the parking area. The drainage system can be done at the same time the fence is removed and realigned due to the narrow passage ways between the patio fencing and the north fence.

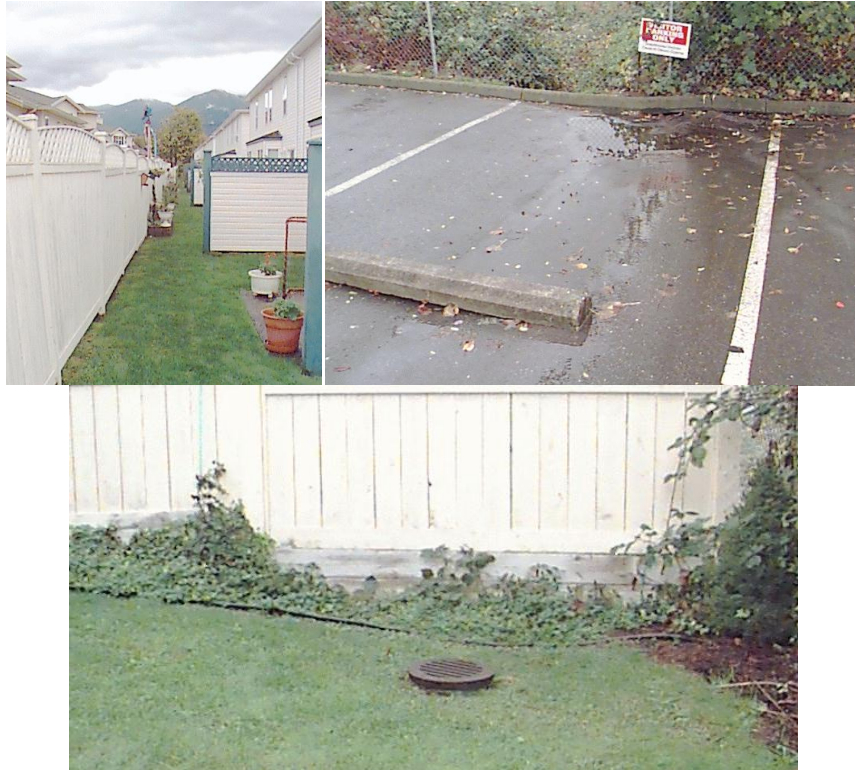
The north fence also has soil, mulch, and vegetation against the bottom of it which will shorten its life expectancy by causing rot. The fence needs to be realigned and it should also be raised to allow air to circulate.

The retaining wall on the neighbouring property should have had a drainage system installed on the south side of the wall or drainage ports installed to allow the ground water that can be trapped behind the wall to escape. We cannot verify the construction of that retaining wall, however all the symptoms of a drainage problem exist on the surface of the subject property that lead us to suspect that this is what is causing the problems. An engineering report would have to be obtained to verify this conclusion.
