NEWSLETTER

MAY, 2010

CS99.11.05 GARDEN PATIOS CAN RESULT IN A PARKADE WATERFALLS

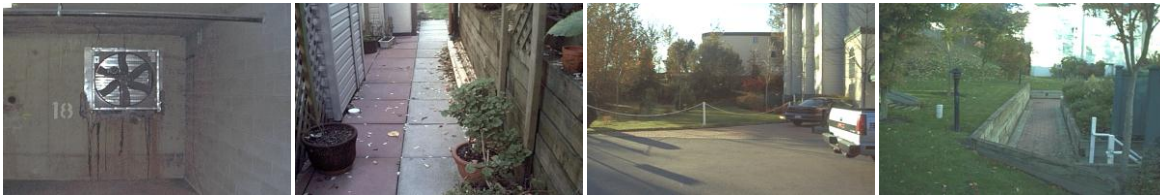
This 44 unit, 4 storey, frame, apartment complex, which was approximately 5 years old at the time of the site survey had water seeps into the parking garage under the north west exhaust fan. At the time of this visit the moisture content in the wall was high.

Drain pipe was capped at the North West corner of the patio of suite 109 next to the exhaust fan in question. In the parking garage, the drain pipe in the west wall (on the same wall as the fan) next to the fan has been capped and is lower than the rest of the drains that come out of that wall.

The retaining wall next to the walkway in front of the patio of suite 109 is bulging and shows signs of high water volume in the earth behind it at times. It should be currently dealt with in order to assess the future cost of restoration of this wall.

The patio and walkway to the patio of Unit 109 will have to be excavated and the organic soil removed and replaced with road mulch. The owner has to re-level his patio slabs frequently because of sand washing out and settlement under them.

The actual solution to the problem cannot be determined until the area is excavated next to the fan and, depending on the situation, there can be several causes with remedial solutions. The first step is to determine if the drain near the patio can be utilized and we assume it can be.
