Case Study: THE HIGH COST OF OBSOLESCENCE

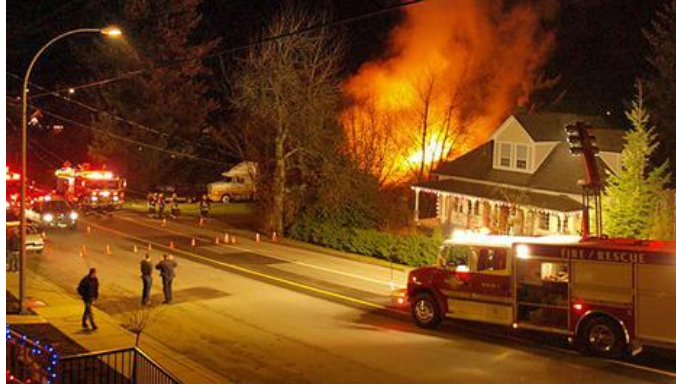
A fire occurred one evening in December of 2010, and when the fire department arrived the rear of the house was fully involved. The fire which had a good hold by the time they arrived and they found that it was hard to extinguish after it spread into the attic space. An excavator had to be brought in to pull apart some still-smoldering portions of the two-story home.

This resulted in the addition left standing as well as the east wall and west section of the original building.

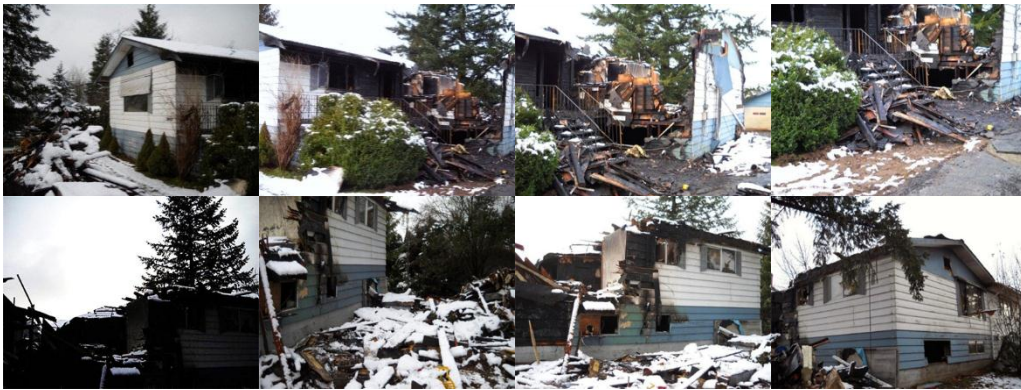
As for the inside it has smoke and fire damage. As for the building materials, they are not to code, obsolete, and under constructed.

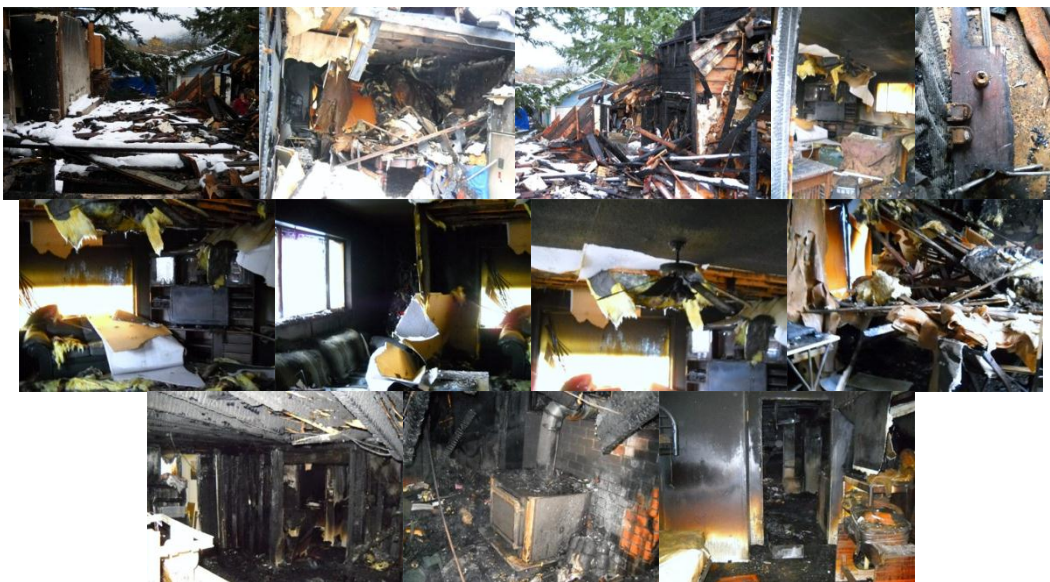
Due to the condition and construction method of the foundation around the perimeter of the dwelling, it renders the entire dwelling obsolete and it would require rebuilding the structure in its entirety.

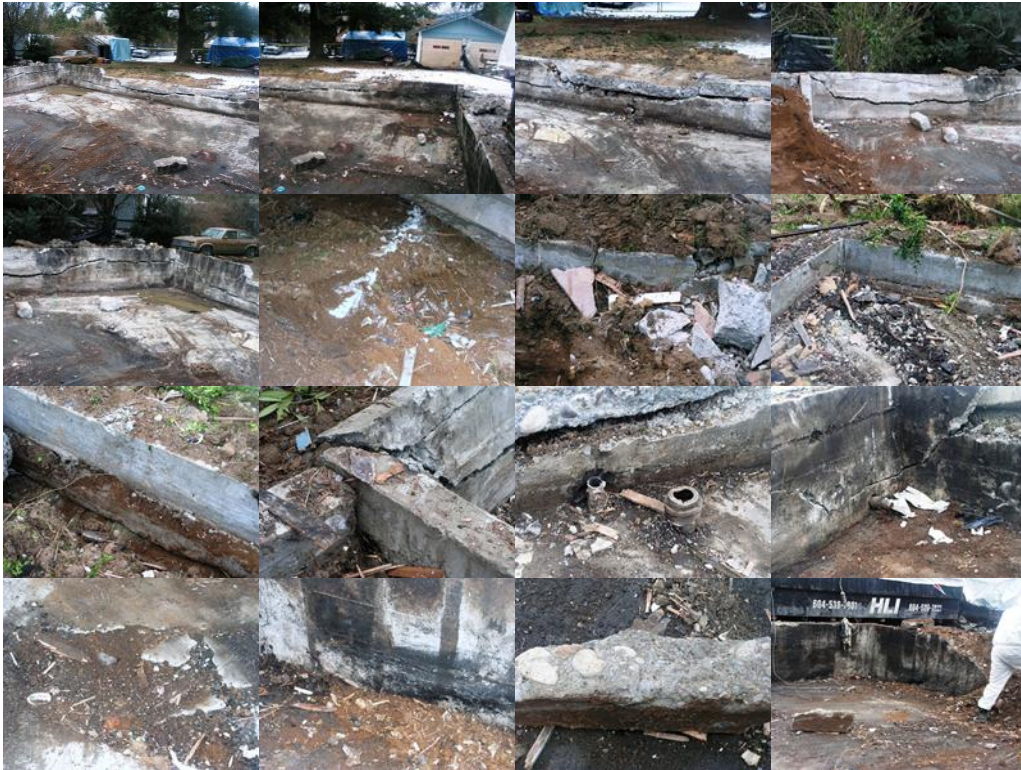
On the surface this seems like a simple solution, however it is not as the building is filled with products that contain asbestos.

This did not happen because there was asbestos present, therefore the restoration company brought in a 24/7 watchman service, portable toilet, and fenced the site. The next step would be to have all services disconnected and an abatement crew to dismantle and remove the balance of the building and debris but there are a few more huddles to jump with this.

- Because there is asbestos, the containers the building is to be placed in are lined with heavy plastic sheets in order to contain the contaminants and while filling these containers the debris cannot be compacted therefore more containers would be required than normal.
- Because it was a fire, the containers cannot be filled until 8 consecutive days later due to the possibility of sparks reigniting.
- Because the debris is mixed and not sorted, it had to be disposed of in a facility that could dispose of it safely which was miles away.
- The fence had to be lined with plastic to prevent the possibility of asbestos dust from escaping out of the confined area.

Once this was accomplished, the foundation hole was filled in and the lot leveled.
