INTEGRAL CONSULTANTS

NEWSLETTER

DECEMBER, 2008

IT' RAININ' IN HERE HOSS!

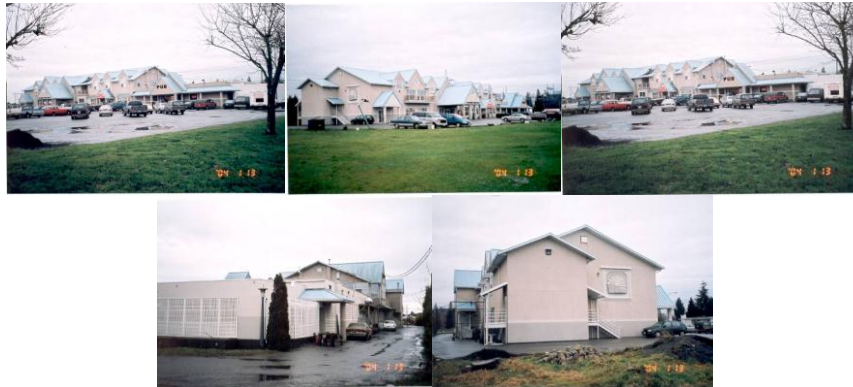
Built in 1991 (E), the complex was constructed with EIFS, staggered setbacks, good fronts, mansard fascia, drywall, ornamental finishes, carpet, plain terrazzo, extensive lighting and outlets, good plumbing, and warm and cool air (zoned).
