INTEGRAL CONSULTANTS

NEWSLETTER

AUGUST, 2009

TIMBER!

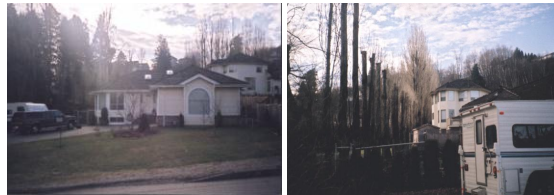
When we visited the site, the weather was overcast but dry. The residence is a 9 year old one storey frame dwelling with an attached garage and basement.

A tree being topped by the neighbour to the south fell onto the Insured's roof, striking the roof over the dining room and damaging the wood shakes, trusses, fascia, soffits and gutters. The shock of the impact was felt throughout the residence. An inspection and observations of the attic made by an independent third party attest to the assumed damage in the attic. The tree then bounced, striking the roof over the living room area and landing on the east fence. The lower portion of the trunk damaged the southern fence line as the tree fell.

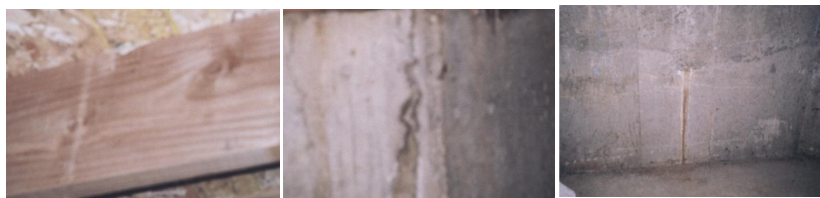
All the damage I observed is concurrent with the type of damage that can occur from impact or ground movement. Even though some normal settlement cracks are in evidence, they would have to be assumed with the repairs as they are conditions that existed before the impact and now form part of the damage.

Until such time that repairs has been completed, additional damage as a result of the impact may occur.
