INTEGRAL CONSULTANTS

NEWSLETTER

SEPTEMBER, 2009

WHAT THE SUN CAN DO!

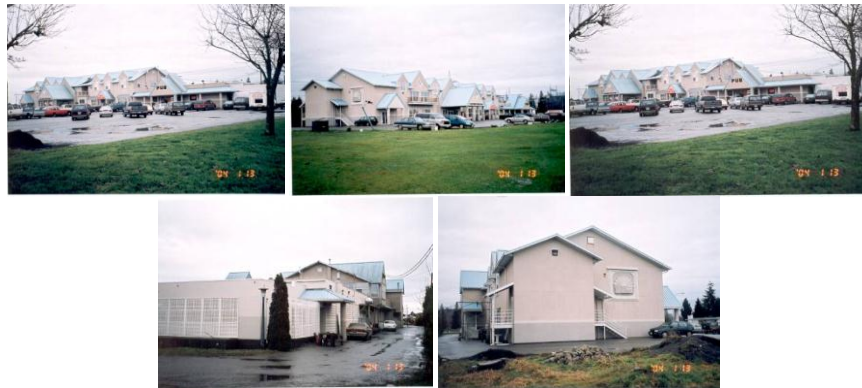
The power lines supplying power to the complex caught fire the evening of November 8th, 2006, at the junction where the supply lines from the pole are attached to the lines to feed the building. The lines from the pole to the building were changed by BC Hydro in the early hours of the morning of November the 9th.

Once the damaged lines were removed, the condition of those lines showed ultra violet rays from the sun had deteriorated the protective casing exposing the wire itself (see photos below). This could cause two of the hot lines to touch each other causing the fire.

Within a week, permanent service was installed, and within 30 days after that repairs were completed. The total cost of loss was confined to in excess of \$ 100,000 including business interruption and consequential damage from loss of stock and product.
