# NEWSLETTER

APRIL, 2010

## CS06.11.11 – WHAT THE SUN CAN DO!

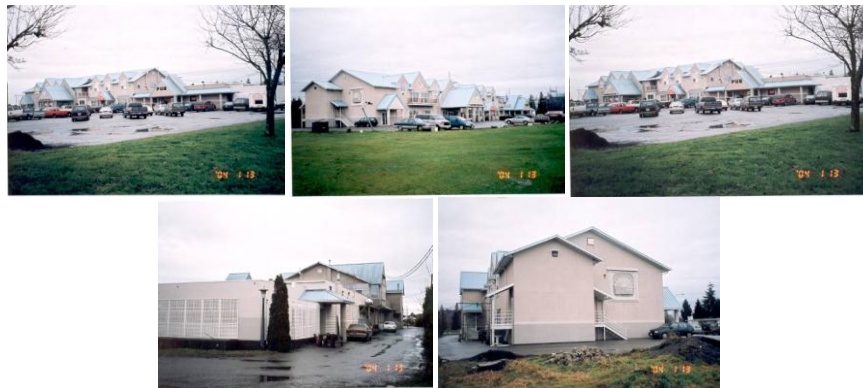
The power lines supplying power to the complex caught fire the evening of November 8<sup>th</sup>, 2006, at the junction where the supply lines from the pole are attached to the lines to feed the building. The lines from the pole to the building were changed by BC Hydro in the early hours of the morning of November the 9<sup>th</sup>.

Once the damaged lines were removed, the condition of those lines showed ultra violet rays from the sun had deteriorated the protective casing exposing the wire itself (see photos below). This could cause two of the hot lines to touch each other causing the fire.

Within a week, permanent service was installed, and within 30 days after that repairs were completed. The total cost of loss was confined to in excess of \$ 100,000 including business interruption and consequential damage from loss of stock and product.
