The TGIF CHRONICLES

For Friday July 9, 2004

Volume 2 – Issue 22

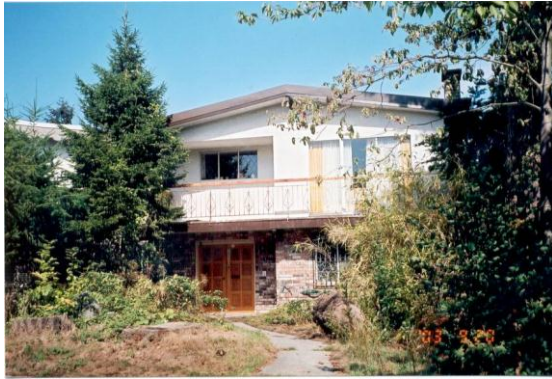
BEFORE

Editors Note: Thanks Kathy, we have taken your photo and added our original photo to give the readers a before and after photo. Aside from a break in point of view whereas a burglar can hide from the view of the street and your neighbours in order to gain entry into your home, here is another reason why it is important to keep the vegetation away.

Low spots or depressions in the topography can result in ponding water that may exert hydrostatic pressure against the foundation. This pressure can cause a variety of effects on the building. A high water table or excessive ground saturation can also impact septic systems. Even over watering of gardens and shrubbery can have significant effects as well. A similar impact can result from tree roots growing against the foundation and causing cracking or movement of the structure.

It is a standard recommendation that the lot grading slopes away from the building. Grading should fall a minimum of one inch every foot for a distance of six feet around the perimeter of the building. It is important also that tree branches are not permitted to overhang the roof and that all landscaping is kept well pruned and not permitted to grow up against any part of the building. This will help prevent the development of pest and insect problems.

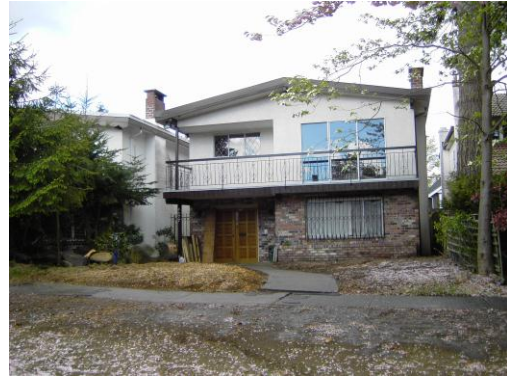
AFTER

“Here is a recent photo of our front yard - the stumps are gone as is the small pine that was at the side of the house.”
